The Dahshour (Egypt) Earthquake of 12th of October 1992

Paper No. 7.25

M.M. Soliman

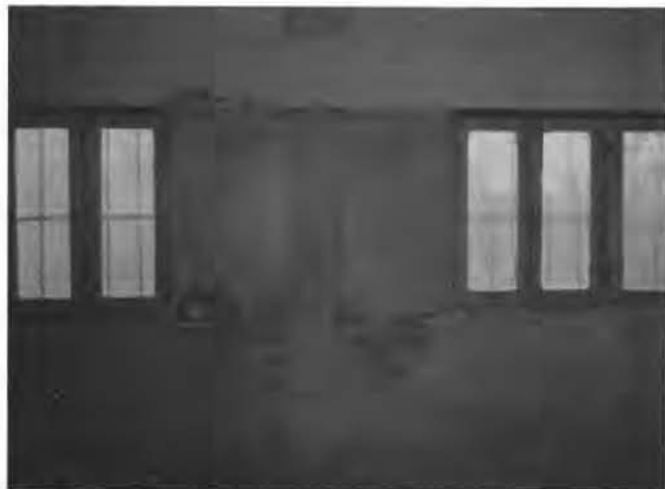
Short column effect was also common in this earthquake, specially in schools where large windows are located in the outer walls to provide ventilation and lighting. Fig 5 presents an example of short column failure as observed in several schools in El-Roddah, El-Ayat and Tameiah Cities.

Fig 5 Shear Failure of a Short Column Arising due to the Existence of Large Windows.

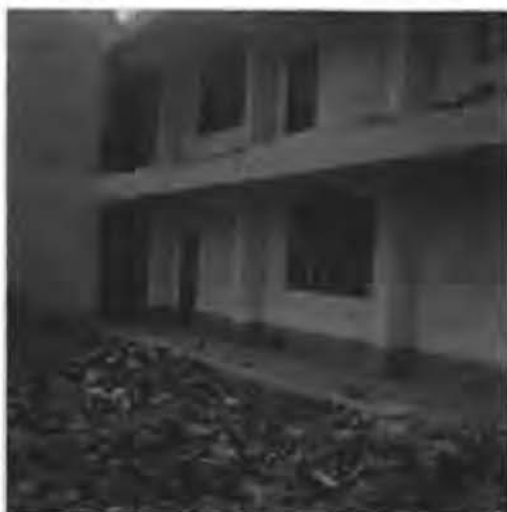
The collapse of parapets was one of the observed failure patterns. Many cases of injuries and fatalities occurred due to this mode of failure. Fig 6 shows the collapse of the parapets of a school building in Tameiah City. Most of the parapet was damaged during the earthquake while the rest was demolished later on.

Fig 6 Failure of Parapets due to the Absence of Lateral Support

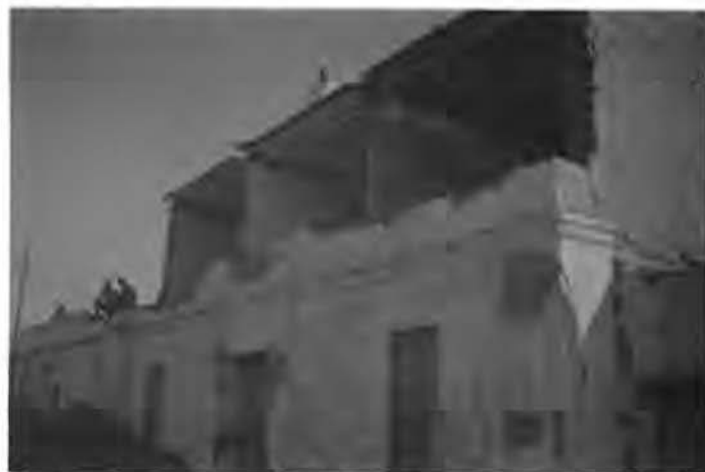
Out-of-plan movements of the outer walls is one of the common damage patterns. This led to the collapse of many walls and parapets of the upper floors causing many cases of injury and death, Fig. 7.

Fig 7 Collapse of Outer Walls of a Two Story Adobe Building

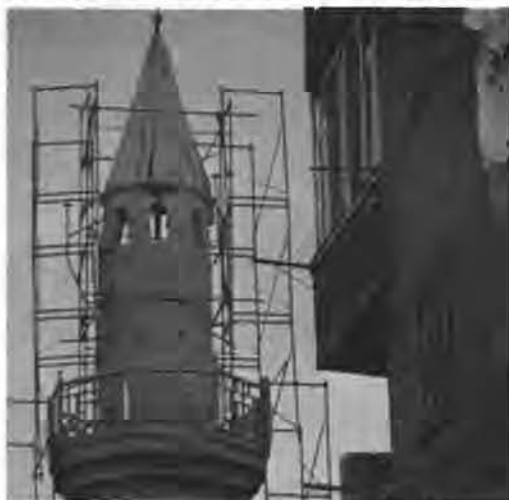
The damage in mosque minarets due to their extensive deformation is another observed pattern in this earthquake. This was combined, in most cases, with the falling down of the heavy metallic crescents on the minaret top. Fig 8 gives an example of this pattern where the damage of the minaret of El-Hady El-Yousefy mosque is shown. Many cracks in the walls of this mosque were also observed. Similar damage was also observed in the historical mosques of El-Azhar, El-Sultan Barkoque, Abou Bakr Mazhar, and El-fakahany. Severe damage in the minaret of El-Sultan El-Ghoury mosque was observed where the minaret was completely separated from the mosque and tilted out-ward.

Fig 8 Damage of the Minaret of El-Hady El-Yousefy Mosque
